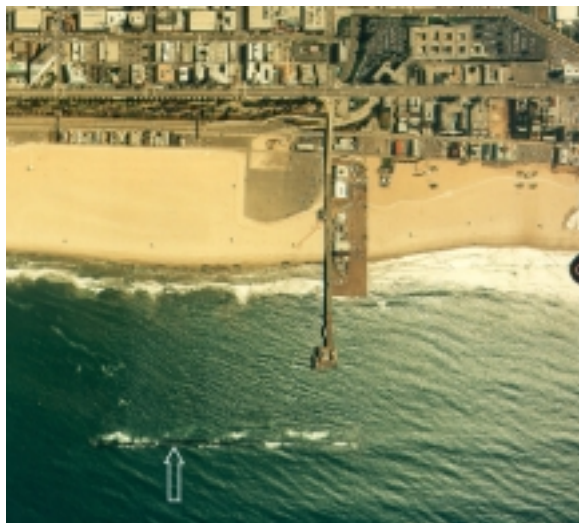
Offshore breakwater at the Santa Monica Pier. Note buildup of sand behind breakwater.

Breakwaters are generally installed offshore to provide harbor protection. Breakwaters may have the additional effect of preventing the shoreline from eroding and may result in sand buildup. An example of this is the offshore breakwater constructed in front of the Santa Monica Pier. After construction of this offshore breakwater, the beaches around the foot of the Santa Monica Pier accreted substantially. Generally these types of onshore accretions do not cause any significant loss of sand to downcoast locations once they have stabilized and reached equilibrium.

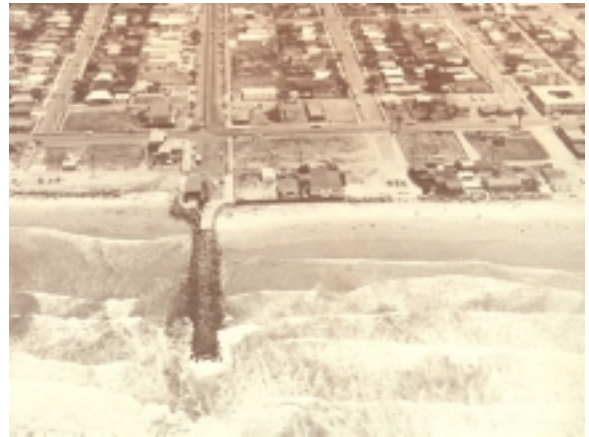
Rock groin used to limit sand movement along the shore. An effective shore protection device if sand fill is made on the up coast side. Source: Shore Protection in California.

groins, breakwaters, rock revetments, seawalls, and seacave fills. Groins (jetties at harbor entrances) are constructed perpendicular to the shoreline to interrupt the migration of sand along a beach. Because of the effects of littoral drift, they typically trap sand on one side and starve the beach on the opposite side. They are normally constructed of rock, reinforced concrete, steel sheet piling, wood planking or a combination thereof. If properly engineered and backfilled with sand, groins can be very effective in limiting the impact of wave erosion on a shoreline. Examples of the success of this type of structure are the beaches in Santa Monica that are roughly 400-600 feet in width today. They were created by the construction of a series of groins perpendicular to the shore and backfilled with sand materials

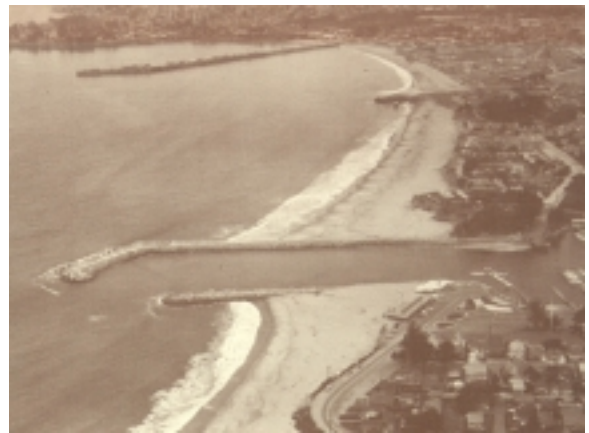
Example of rock jetties protecting a harbor entrance. Source: Shore Protection in California.

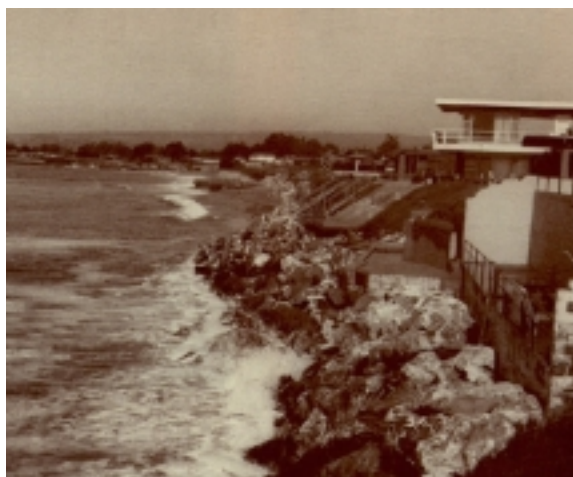
*Example of rock revetment used as shore protection device.
Source: Shore Protection in California.*

Rock revetments (the onshore version of an offshore breakwater) will generally be constructed at a 2:1-1/2 to 2:1 slope and therefore can extend for some distance out onto the beach.

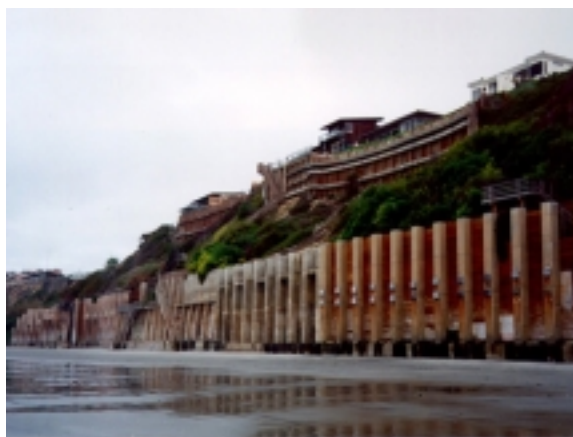
Massive sea walls previously constructed in Encinitas. This type of sea wall is no longer typical.

Seawalls are normally parallel to the shoreline and generally occupy less sandy beach area than other types of structures. Seawalls are usually constructed of reinforced concrete, steel sheet piling or wood planking. Wood planking is the least desirable material in that it has a much greater failure rate than seawalls constructed of either steel sheet piling or reinforced concrete.

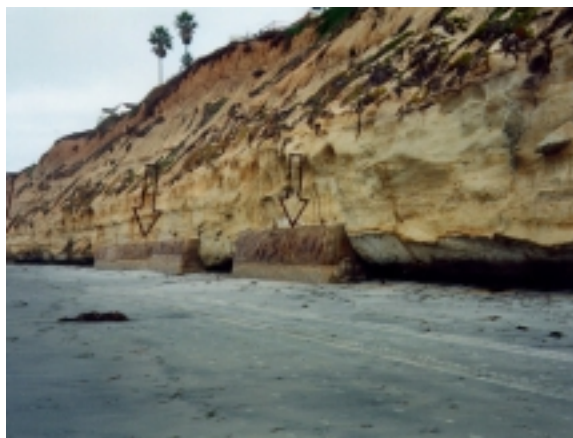
Current less obtrusive sea walls, notch fills.

Seacave fills, or bluff notch fills, are located completely within and behind the bluff face and, according to the California Coastal Commission, have less impact on beaches. In northern San Diego County, seacaves or notches form as a result of waves and wave thrown cobble impacting the Torrey Sandstone bluffs. This rapid erosion causes an undercutting on the face of the bluff and can ultimately lead to a catastrophic collapse of the bluff face, undermining public and private structures located on the bluff top. These bluff top structures can be either private residential development, commercial developments or public infrastructure such as roads, water lines, waste water lines, power lines, etc. Because of the nature and location of these structures, most have relatively high monetary value. Loss of private structures impacts state and local government in that it removes high value properties from the tax base and often involves the Federal Emergency Management Agency (FEMA) program.

Recent seacave fills use a "leaner" cement mix intended to allow the fill to erode at the same rate as the adjacent bluffs. Thus, the fill of seacaves does not result in a loss of beach area otherwise available for public recreational use, and the back of the beach is not permanently fixed in place. The seacave fill will not prevent the erosion of unprotected bluff face material onto the beach since it will not cover any portion of the bluff as a seawall or upper bluff work would. The upper portion of bluffs may continue to erode from natural causes of wind, rain, and surface run off.⁷
